TAILINGS DAMS RISK OF DANGEROUS OCCURRENCES

Lessons learnt from practical experiences

Bulletin 121

ICOLD COMMITTEE ON TAILINGS DAMS AND WASTE LAGOONS
(1995-2001)

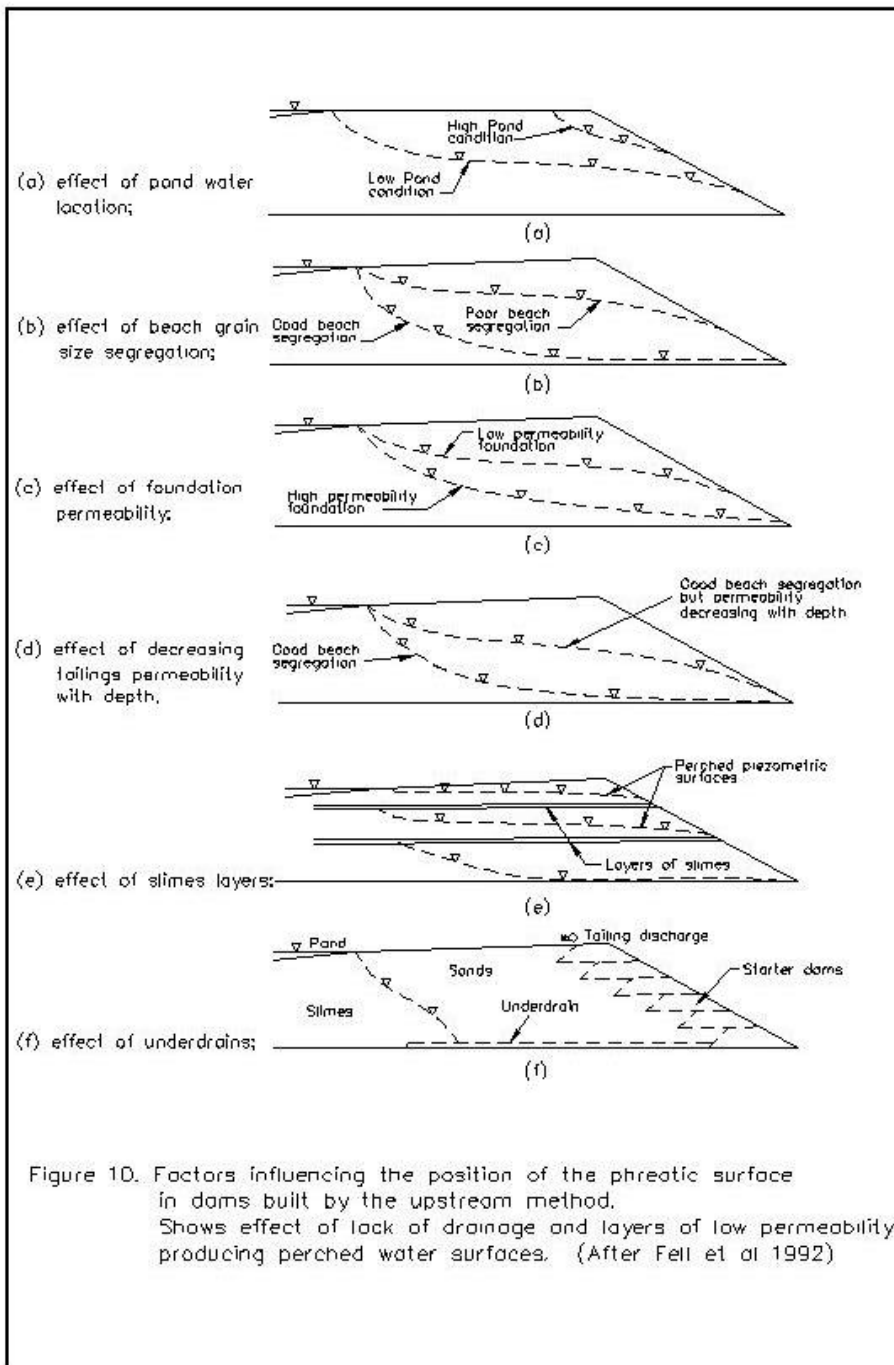
Figure 10. Factors influencing the position of the phreatic surface in dams built by the upstream method. Shows effect of lack of drainage and layers of low permeability producing perched water surfaces. (After Fell et al 1992)

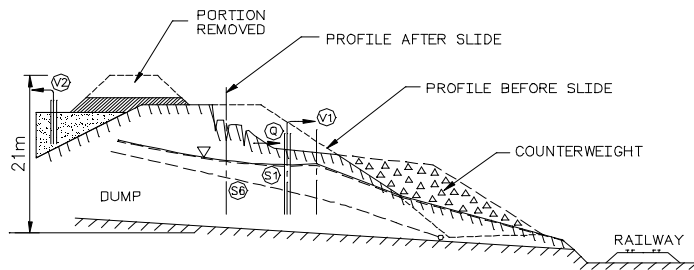
Figure 12. Section of starter dam formed by an existing dump.

- S1 = PHREATIC LINE 1 DAY BEFORE SLIDE
- S6 = PHREATIC LINE 6 DAYS BEFORE SLIDE
- Q = WATER ESCAPING FROM HIDDEN COARSE LAYER
- V1 = WELLPOINTS FOR REMOVAL OF POREWATER FROM DAM BODY
- V2 = WELLPOINTS FOR REMOVAL OF POREWATER FROM SEDIMENTED TAILINGS

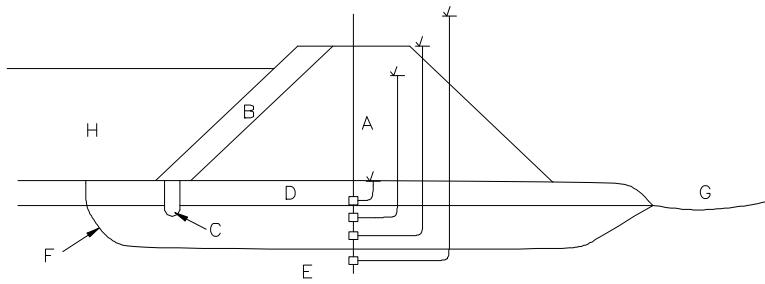
Figure 13. Section of Aznalcóllar Tailings Dam.

- A WASTE ROCKFILL.
- B EARTHFILL.
- C SLURRY TRENCH CUT-OFF.
- D ALLUVIAL SAND AND GRAVEL ABOUT 4m THICK.
- E BLUE MARL 60m THICK. $k = 10^{-11}$ to 10^{-12} m/s.
- F SLIP SURFACE. $c' = 0$, $\phi' = 16^\circ$
- G RIVER
- H TAILINGS. $\gamma = 28 \text{ kN/m}^3$

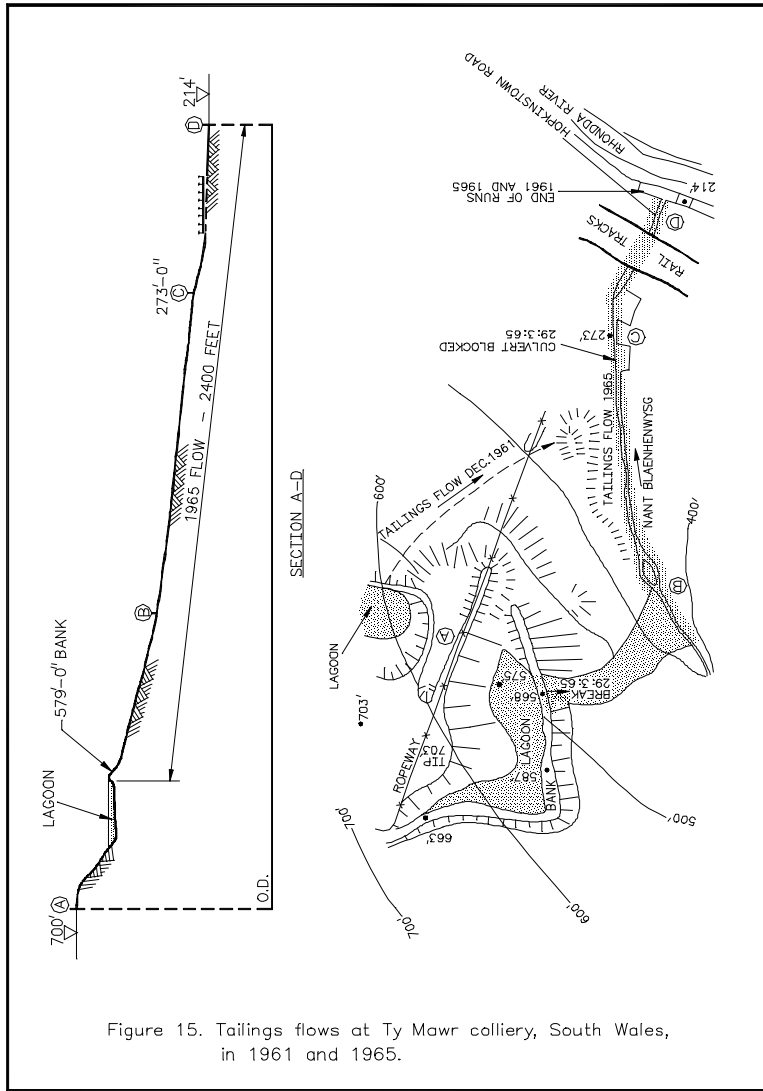
Figure 15. Tailings flows at Ty Mawr colliery, South Wales, in 1961 and 1965.

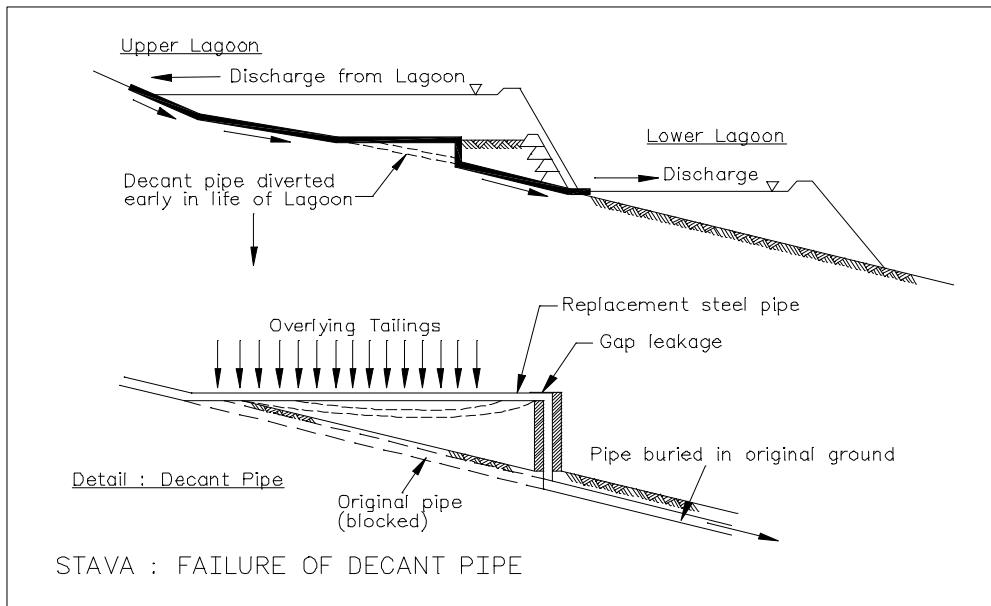
Figure 16. Failure of the decant pipe at Stava.
